A. INTRODUCTION

B. VEGETATION**SENECA FALLS PROPERTY**

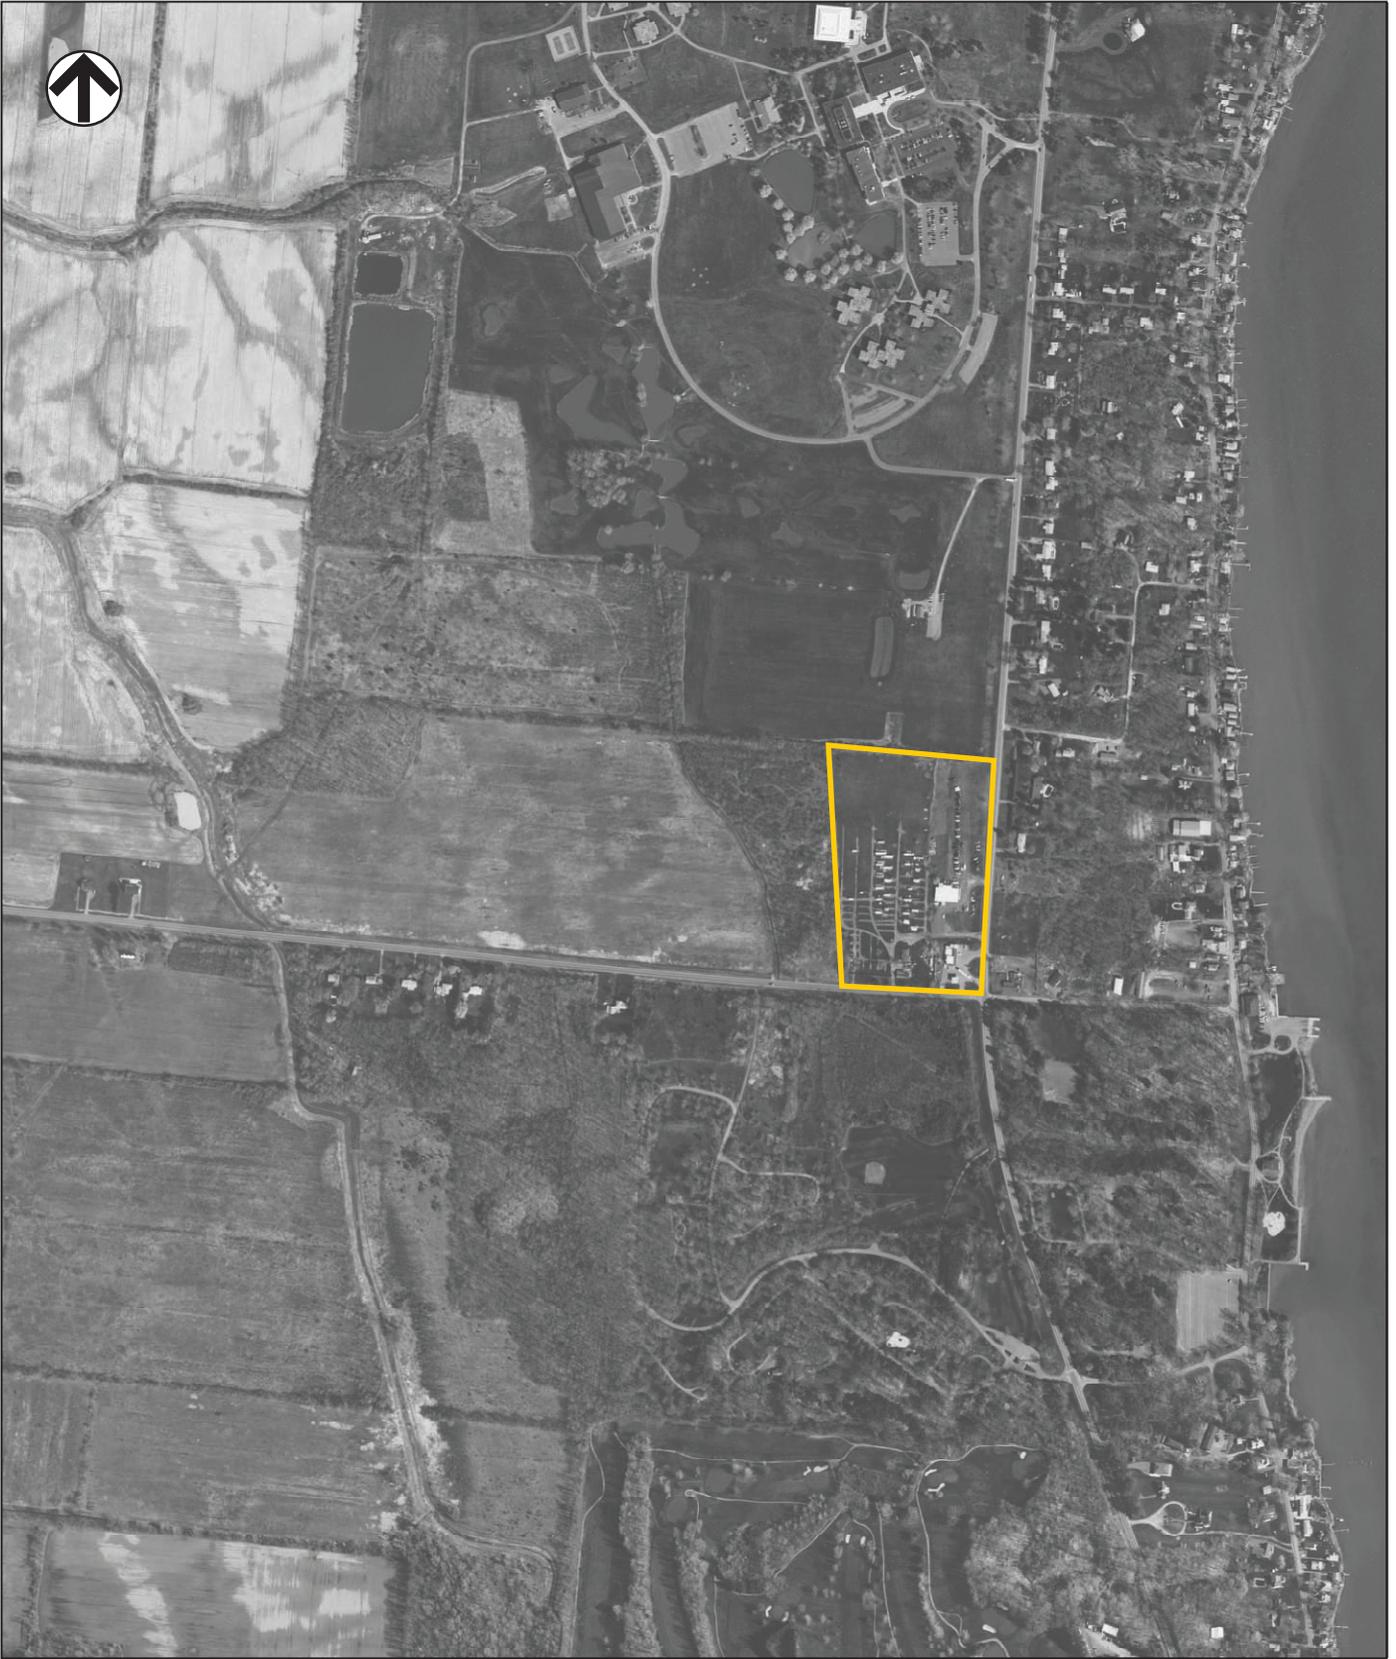
The Nation’s property in Seneca Falls consists entirely of open, mowed lawn area occupying a former campground and including several outbuildings and a gas station. The site is very level in topography. Gravel drives giving access to the former camp sites are still evident and the site has been maintained (mowed) up to the present day. Scattered trees generally 6-10 inches in diameter constitute the only woody vegetation found within the project site. American sycamore (*Platanus occidentalis*), weeping willow (*Salix babylonica*), common buckthorn (*Rhamnus cathartica*) and silver maple (*Acer saccharinum*) occur sporadically within the campground as shade trees for the camp sites.

Immediately west of the subject property and bordering the site, a wooded wetland occurs that contains a range of plant species, including Virginia Rose (*Rosa virginiana*), red osier dogwood (*Cornus stolonifera*), arrowwood (*Viburnum recognitum*), American elm (*Ulmus americana*), swamp white oak (*Quercus bicolor*), soft rush (*Juncus effusus*), and apple (*Malus/Pyrus sp.*). Although located offsite, this wooded wetland contributes to the habitat value of the subject property, offering foraging and refuge opportunities for animal species that utilize both open areas and wooded wetlands. See Figure 3.6-1 for an aerial photograph of this site.

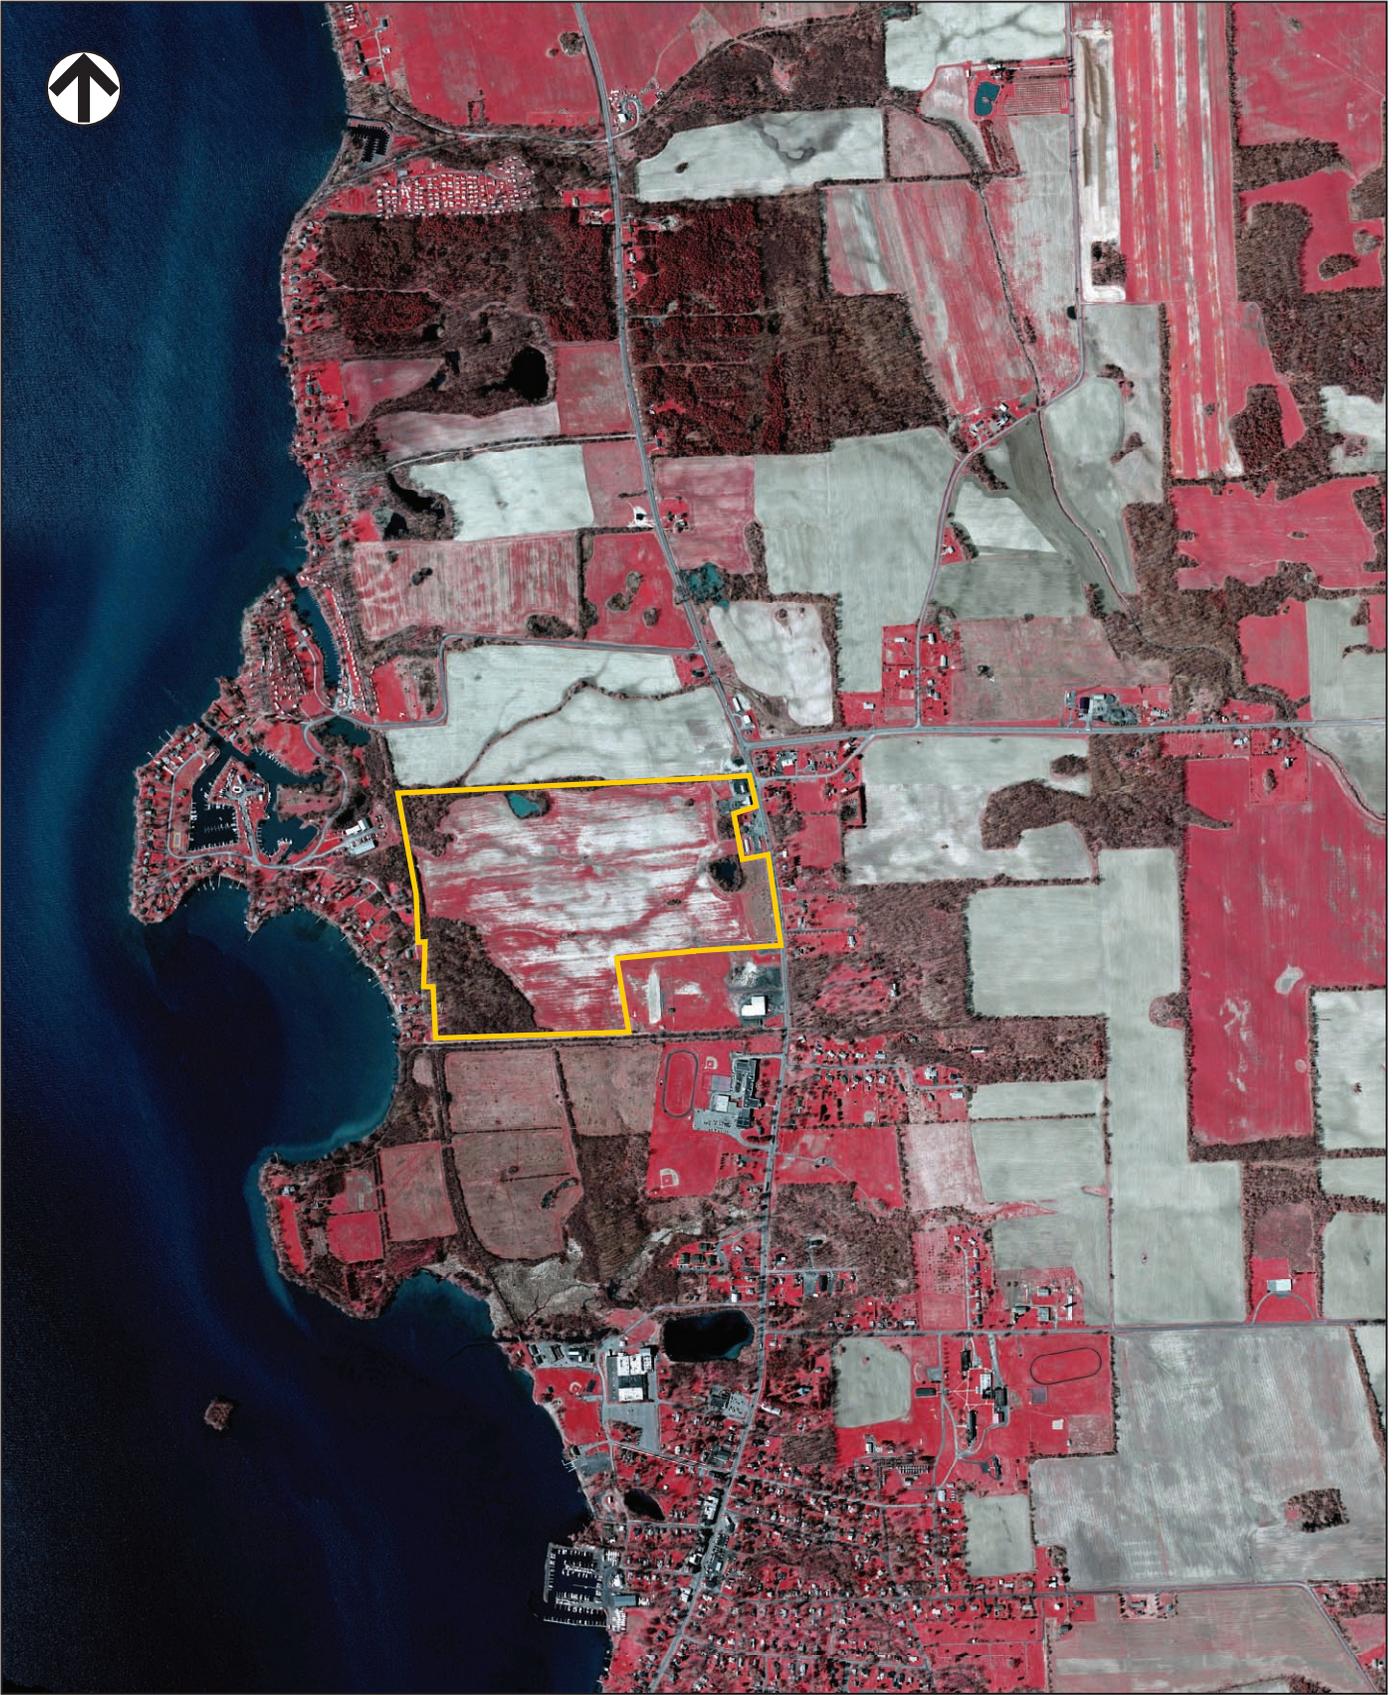
Two open water pond areas are located on the Nation's Union Springs property as shown in Figure 3.6-2. One is located along the northern property boundary. The other is in the eastern

portion of the site. Both have a narrow fringe of shrubs/trees where the edge of field clearing (agricultural activity) has stopped historically allowing woody vegetation to persist. Such species as green ash (*Fraxinus pennsylvanica*), swamp oak (*Quercus bicolor*), common buckthorn (*Rhamnus cathartica*), shagbark hickory (*Carya ovata*), box elder (*Acer negundo*) and sedges (*Carex sp.*) are common immediately adjacent to the open water areas.

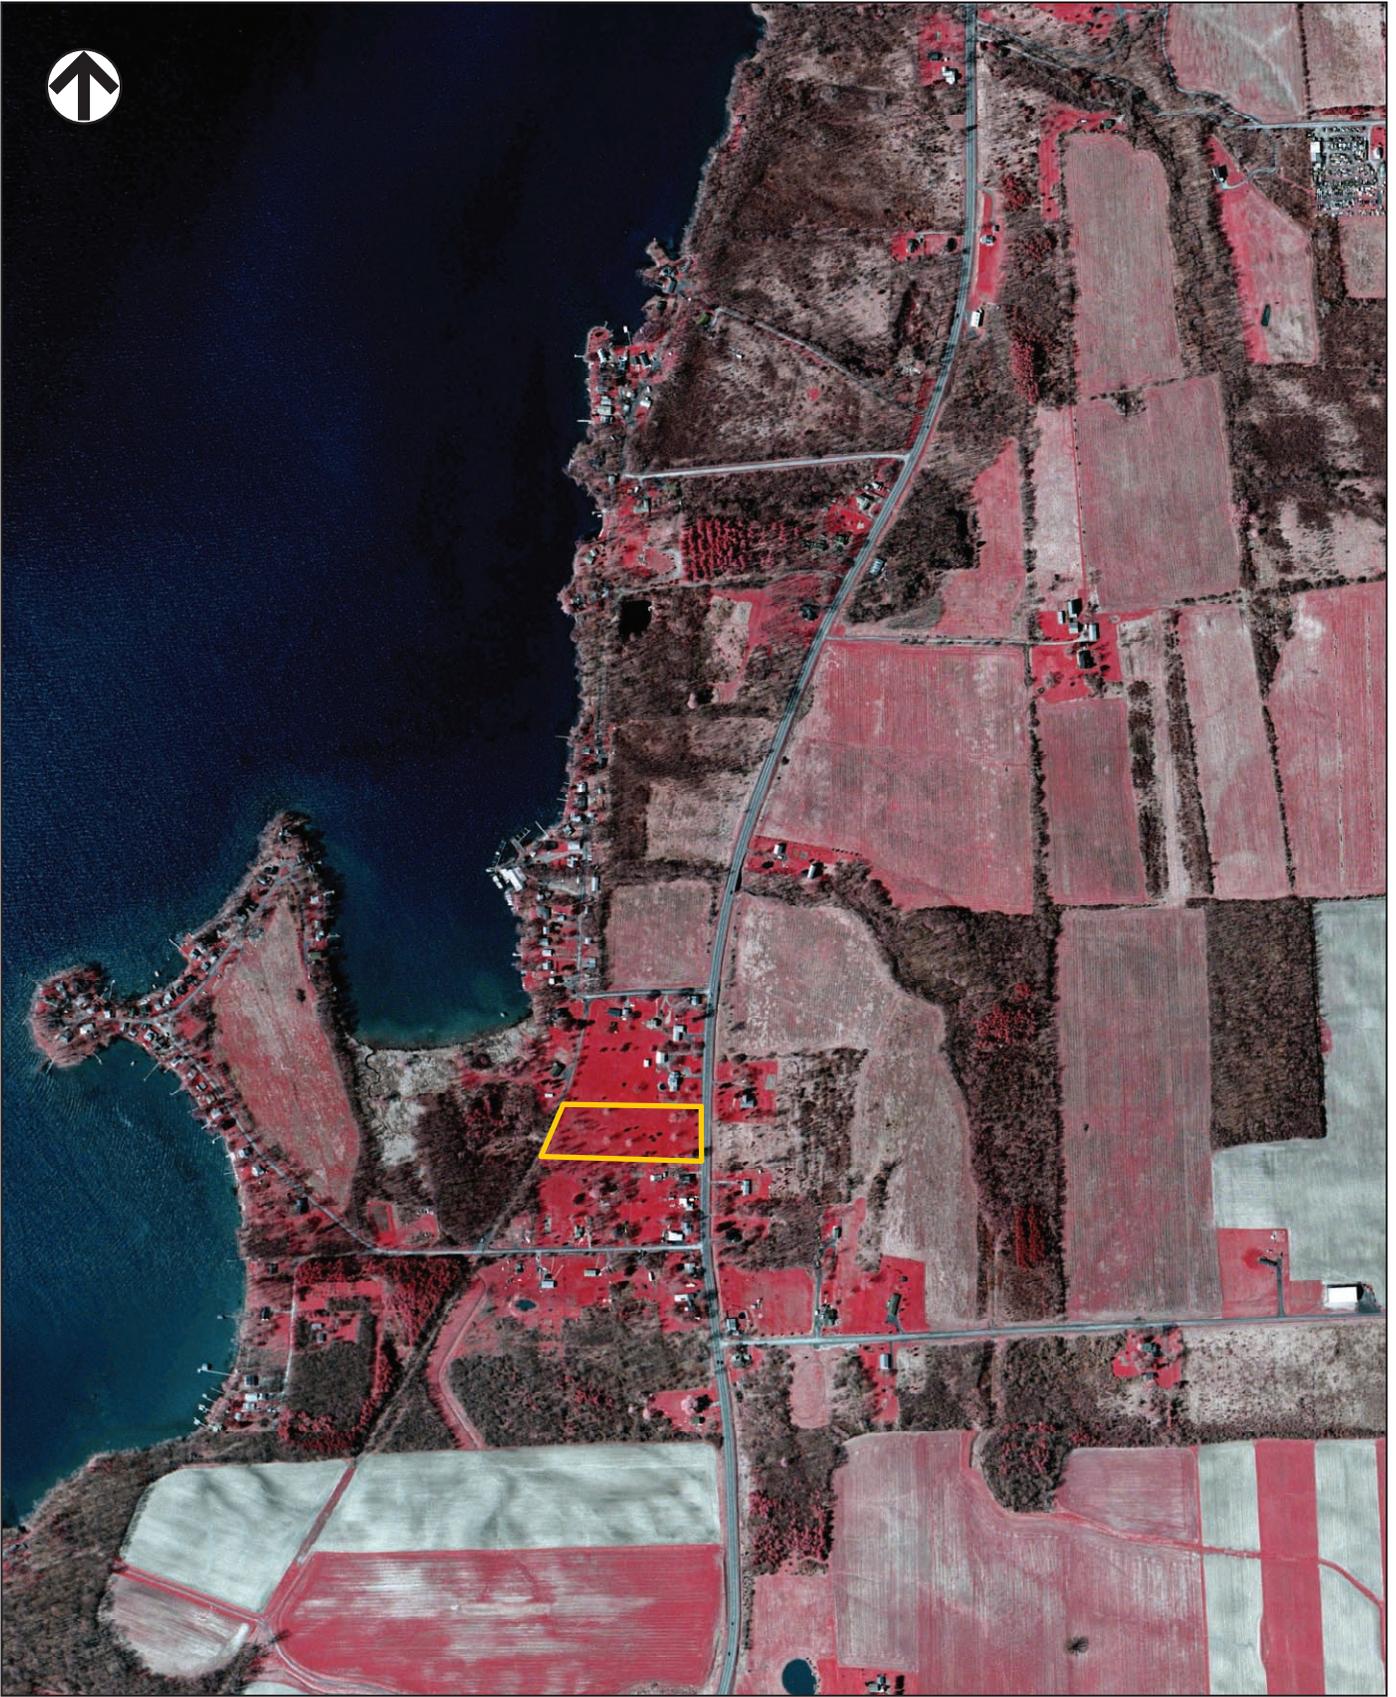
The Nation's property in Springport consists of an open, mowed lawn comprising a residential lot, bounded to the north and south by existing single family residential homes. The property's lawn area has individual scattered trees as landscape features, dominated by green ash (*Fraxinus pennsylvanica*) with diameters ranging from 6 to 20 inches. Green ash is most prevalent in the western portion of the property at its lower elevations. Also present are cottonwood (*Populus deltoides*), red pine (*Pinus resinosa*) and eastern red cedar (*Juniperus virginiana*) and balsam fir (*Abies balsamea*) further east, closer to Route 90. A narrow drainage swale runs along the southern boundary of the property, separating it from the residential lot to the south. Tartarian honeysuckle (*Lonicera tatarica*), Norway maple (*Acer platinoides*), black walnut (*Juglans*

nigra), orchard grass (*Dactylis glomerata*), and box elder (*Acer negundo*) occur within the unmowed portions of this swale. See Figure 3.6-3 for an aerial photograph of this site.

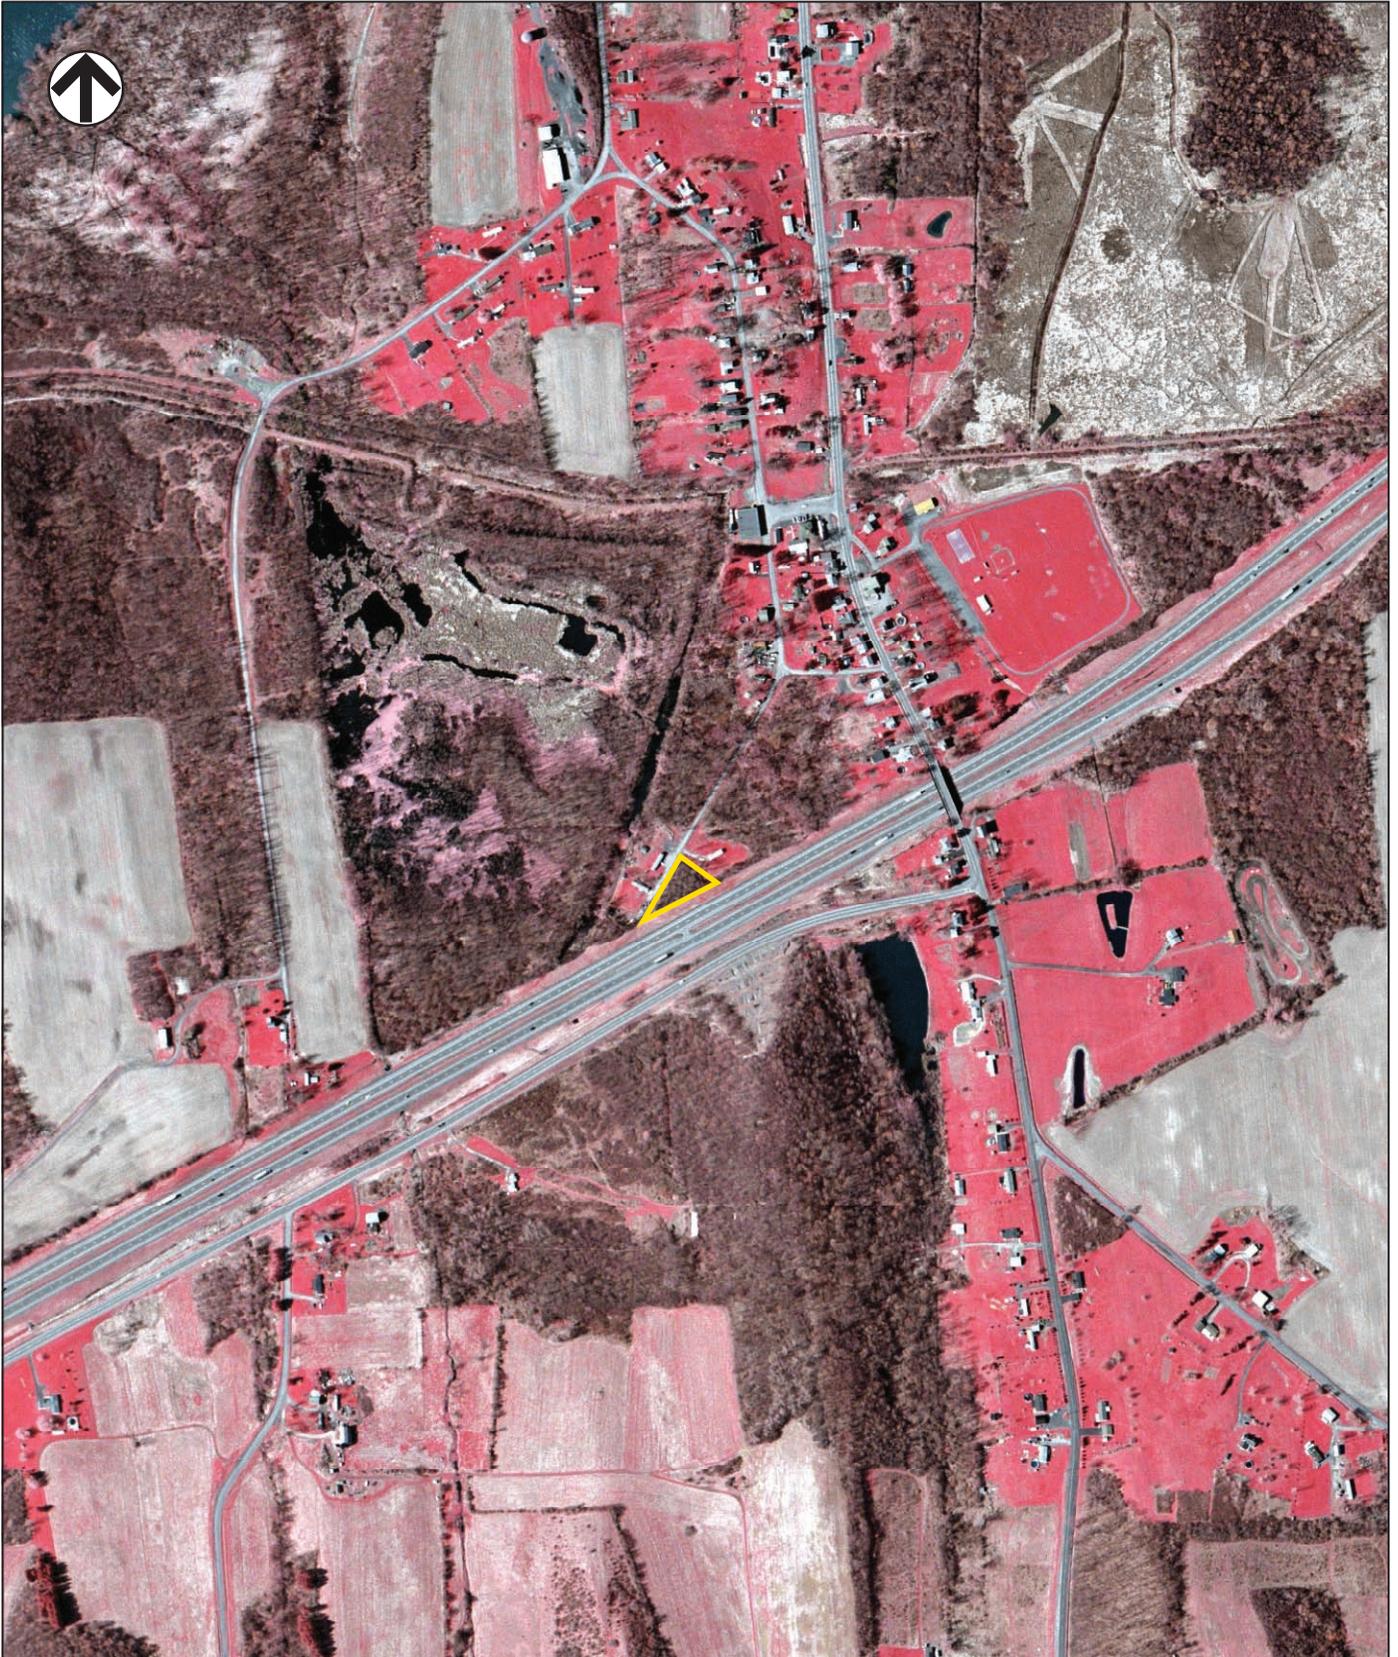
The Montezuma property is a very small (0.05 acre) site bounded by I-90 to the south, High Street to the northwest and a residential yard to the east. It is primarily a small patch of young, upland forest dominated by buckthorn (*Rhamnus cathartica*), hawthorne (*Crataegus sp.*) and sweet cherry (*Prunus avium*) 2 to 8 inches in diameter at breast height ("dbh"), with an understory of Virginia Creeper (*Parthenocissus quinquefolia*), poison ivy (*Rhus radicans*) and swallowwort (*Cynanchum rossicum*). Immediately adjacent to High Street, a small portion of this land is predominated by plants that prefer wetter conditions including American elm (*Ulmus americana*), green ash (*Fraxinus pennsylvanica*), cattail (*Typha latifolia*) and purple loosestrife (*Lythrum salicaria*). Wetter conditions occur due to roadway runoff and lower topography adjacent to the road. Staghorn sumac (*Rhus typhina*) is an early successional species also noted adjacent to High Street. The overall property exhibits low botanical diversity and is isolated by roadways and development. See Figure 3.6-4 for an aerial photograph of this site.
